Investigation of the Bluffs Apartment Fire

Jeff Colwell, Ph.D., P.E.

Colwell Consulting, LLC

July 16, 2021

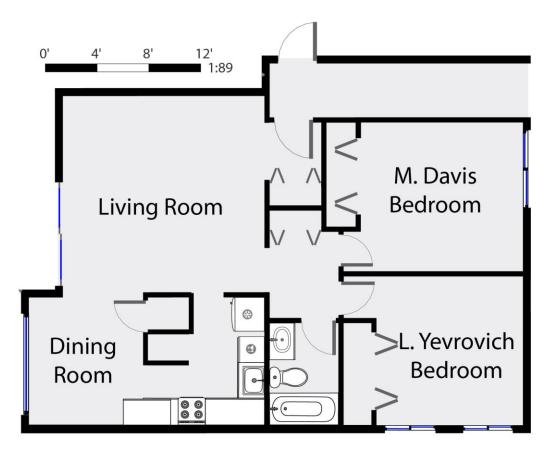
Figure 1 Sketch of unit E101.

- b. Ms. Yevrovich describes seeing smoke coming from Mr. Davis's bedroom, which is what prompted her to investigate the source of the smoke.
 - c. As shown in Figure 1, in order to see into Mr. Davis's room, Ms. Yevrovich would have had to have been standing in the hallway, near the center of the apartment. Therefore, Ms. Yevrovich would have had the opportunity to observe fire burning in other locations of the apartment but she did not. Instead, she only reported fire within Mr. Davis's bedroom.

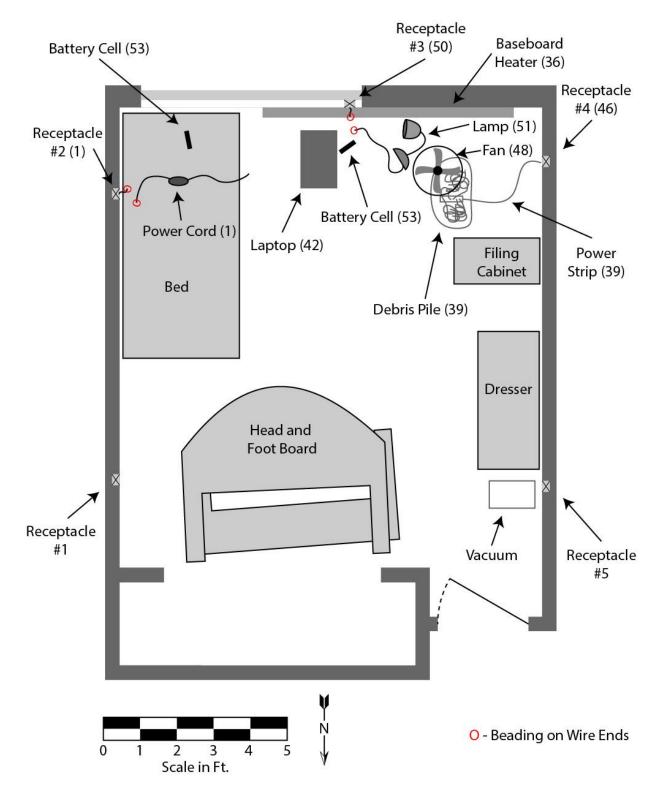
Figure 7 Sketch of Mr. Davis's bedroom and various items identified during excavation.

Fire department investigators conducted a limited scene excavation of Mr. Davis's bedroom after the fire was extinguished. As a part of this excavation, several components were identified, including: remnants of a computer, a power cord, and an outlet with a severed power cord still plugged in. After the fire department excavation, CASE Forensics (now a part of Jensen Hughes) documented and excavated Mr. Davis's room. As a part of this excavation, several additional components were identified, including: a power strip with multiple items plugged into it, a laptop with a severed power cord, a severed power cord plugged into an outlet, and several batteries. A sketch showing the locations of various items found during excavation, when they were first photographed, is shown in Figure 7. Locations at which wires exhibited evidence of beading are indicated with an open red circle in this figure.

- 17. The hypothesis that an electrical fault associated with the lamp cord was the cause of the fire cannot be rejected.
 - a. The location of the electrical fault associated with the lamp cord is shown in Figure7.
 - b. As shown in Figure 10 and Figure 11, both ends of the lamp cord copper conductors exhibit evidence consistent with electrical arcing. This arcing could have acted as an ignition source for the fire or it could have been the result of arcing-through-char once the fire occurred.
 - c. Ms. Yevrovich stated in her interview that she saw other things burning, besides the mattress, in Mr. Davis's room, including laundry, blankets, and other "stuff" This

- 18. The hypothesis that an electrical fault associated with the laptop power cord was the cause of the fire cannot be rejected.
 - a. The location of the electrical fault associated with the laptop power cord is shown in Figure 7.

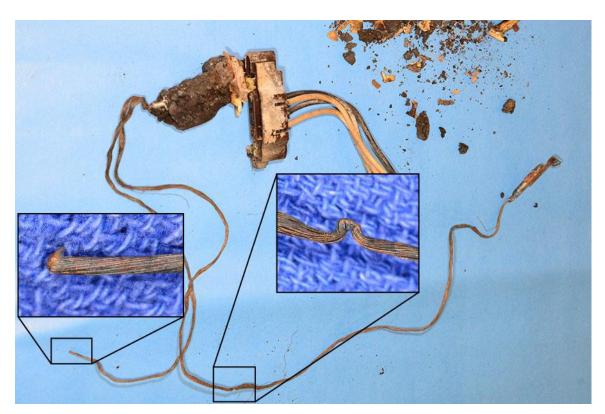
Figure 12 Receptacle #2 and associated power cord fragment (Item #1).

- d. The location of this arc is mid-span and as a result, is not involved in the creation of the electrical terminations that are present on both of the ends of this conductor. Based on available photographs of the initial excavation, performed by the fire department, it is unclear if this power cord may have been pinched between the frame of the bed and the box spring. If so, this pinching may have damaged the power cord and caused an electrical fault.
- e. As a result, the hypothesis that an electrical fault associated with the laptop power cord was the cause of the fire cannot be rejected

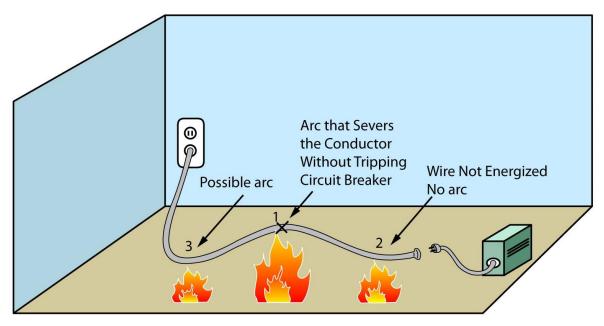
Figure 14 Schematic of arc mapping.

- c. Additionally, section 6.3.21.7 of NFPA 921 (2021) goes on to state that arcing is not more prevalent near the area of origin.
 - i. **6.3.21.7** "Research specifically disproves the concept that arcs will be more prevalent at the area of origin, compared to other locations."

d. Therefore, arc mapping does not support Jensen Hughes' origin determination. Instead, Jensen Hughes has used an approach that is incorrect and counter to that described by NFPA 921 (2021).

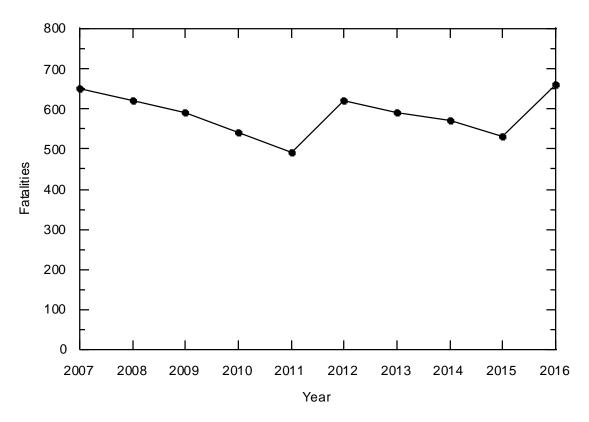
- a. Even cigarettes rated as "fire-safe" can still smolder the entire length of the cigarette, as acknowledged by the Jensen Hughes report. Therefore, ignition of fires by cigarette butts have not been eliminated, in spite of fire safety standards for both cigarettes, mattresses and mattress pads. In fact, fatal residential fires attributed to cigarette butts have remained relatively constant from 2007 to 2016, in spite of the new "fire-safe" cigarettes, as shown in Figure 15 (Ahrens, 2019b).

Figure 15 Fatal home structure fires started by smoking materials (Ahrens, 2019b).
